STAYING SHARP

BAD PARTS? CHECK THE TAILSTOCK

By Mitchell Kirby,
Riten Industries Inc.

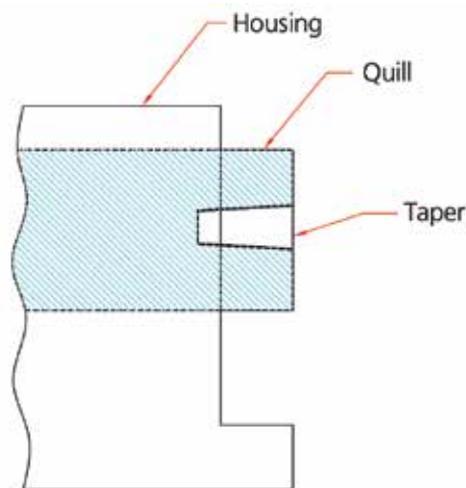
Dead tailstocks consist of a housing and quill with a mounting taper (Figure 1). The taper is commonly a Morse taper, but Jarno and Brown & Sharpe tapers are found on some machines. Live tailstocks add a ro-

Figure 1. Dead tailstock.

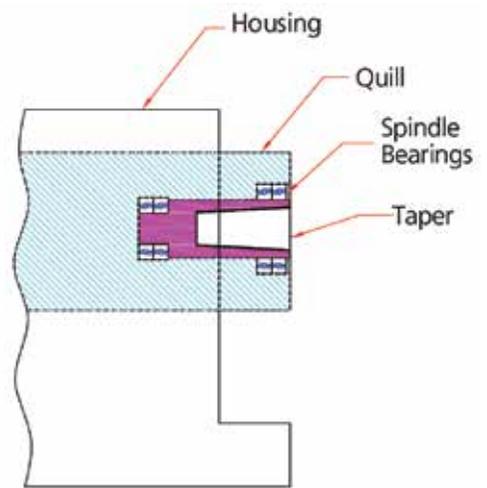
Figure 2. Live tailstock.

tating spindle with bearings to the assembly (Figure 2). Lathes with dead tailstocks require a live center while live tailstocks require a dead center. Because grinders rotate at lower speeds, they may employ live or dead centers in either style of tailstock.

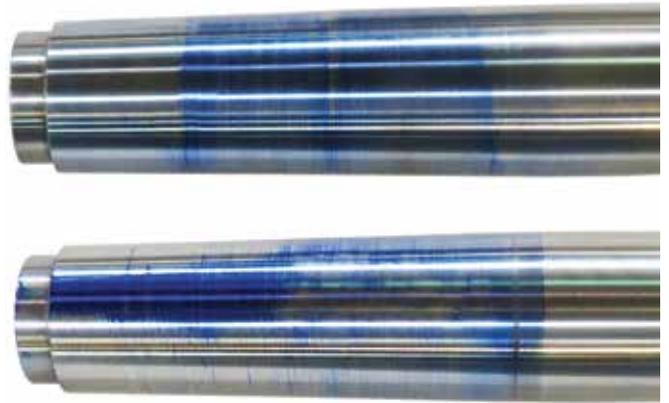
Properly done, bluing the ID with a taper gage will highlight out-of-roundness or other visible damage to the taper (Figure 3). The bluing should be at least 90 percent visible on all surfaces. Any large gaps or heavy bluing are sure signs of a deformed taper.

Figure 3. Bluing on a taper gage should be light and even (top). Heavy bluing indicates the taper did not contact the quill interior, while gaps mean the fit was too tight (bottom).

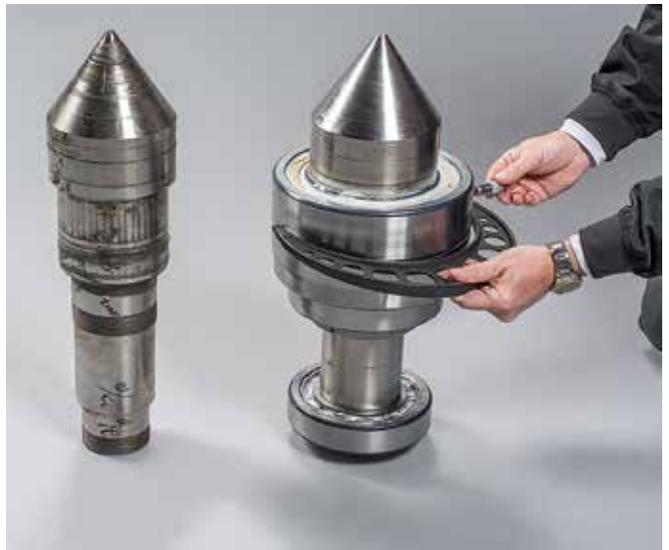
Surprisingly, the taper, in this case a 60° point, had only minor wear, but the spindle bearings were irreparably damaged (Figure 4a). There was also noticeable wear to the bearing seats on the quill ID, indicating the bearings were not seating properly. There was also

Figure 4a (left). A damaged spindle as received, with failed bearings removed. Figure 4b (right). The remanufactured spindle with new bearings installed.

obvious wear on the spindle bearing journals. Running the lathe to the point of catastrophic bearing failure damaged both the quill and the spindle.

The most economical solution was to remanufacture the spindle bearing journals and lightly grind the taper to remove wear and restore concentricity to the new bearing surfaces. Magnetic particle inspection of the rebuilt spindle was performed to ensure its structural integrity. New bearings were installed, making sure they were matched for size and correctly mounted (Figure 4b).

Because the damage to the quill ID was extensive, it was turned oversize and a bushing was manufactured. Once the bushing was installed, the new bearing surfaces were ground to the proper size. Care was taken to maintain concentricity between the bearing ID and the quill OD.

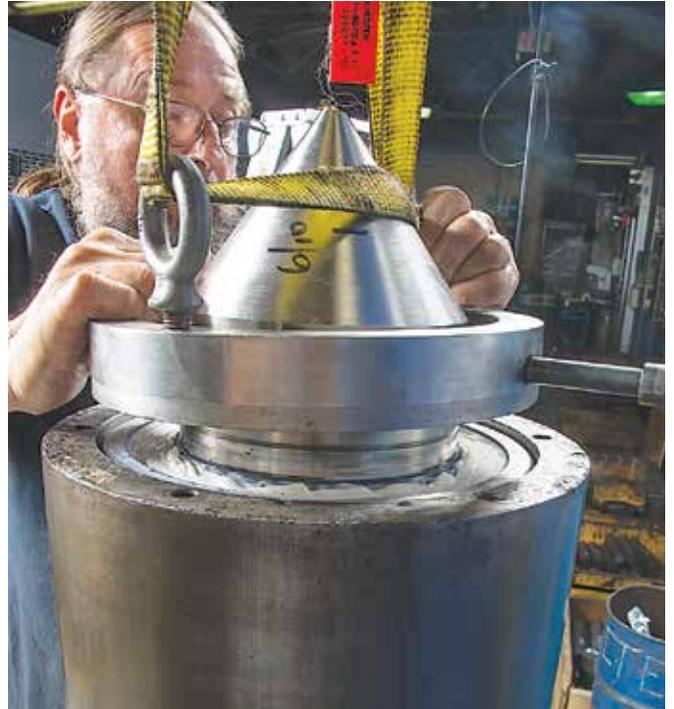
Figure 5. The new spindle is lowered into the repaired quill, achieving a slip fit.

The final step in the process was inserting the new spindle and bearing assembly into the quill. On smaller quills, a simple press fit is usually sufficient. However, in this instance, the housing was more than 5' long, so a more complex slip-fit procedure was required. The spindle was encased in dry ice while a heater was inserted into the quill. During this process, the spindle shrinks and the housing expands. The spindle was then lowered into the quill (Figure 5), and when both were returned to ambient temperature, a precise fit was accomplished. The completed tailstock was then tested to ensure the bearings were functioning properly.
